Phase I Inspection Report
Mongaup Falls Dam
Delaware River Basin, Sullivan County, New York
Inventory No. 321

5. TYPE OF REPORT & PERIOD COVERED
Phase I Inspection Report
National Dam Safety Program

PHASE I INSPECTION REPORT
NATIONAL DAM SAFETY PROGRAM
MONGAUP FALLS DAM, I.D. NO. NY 321
DEC #148D-130
DELAWARE RIVER BASIN
SULLIVAN COUNTY, NEW YORK

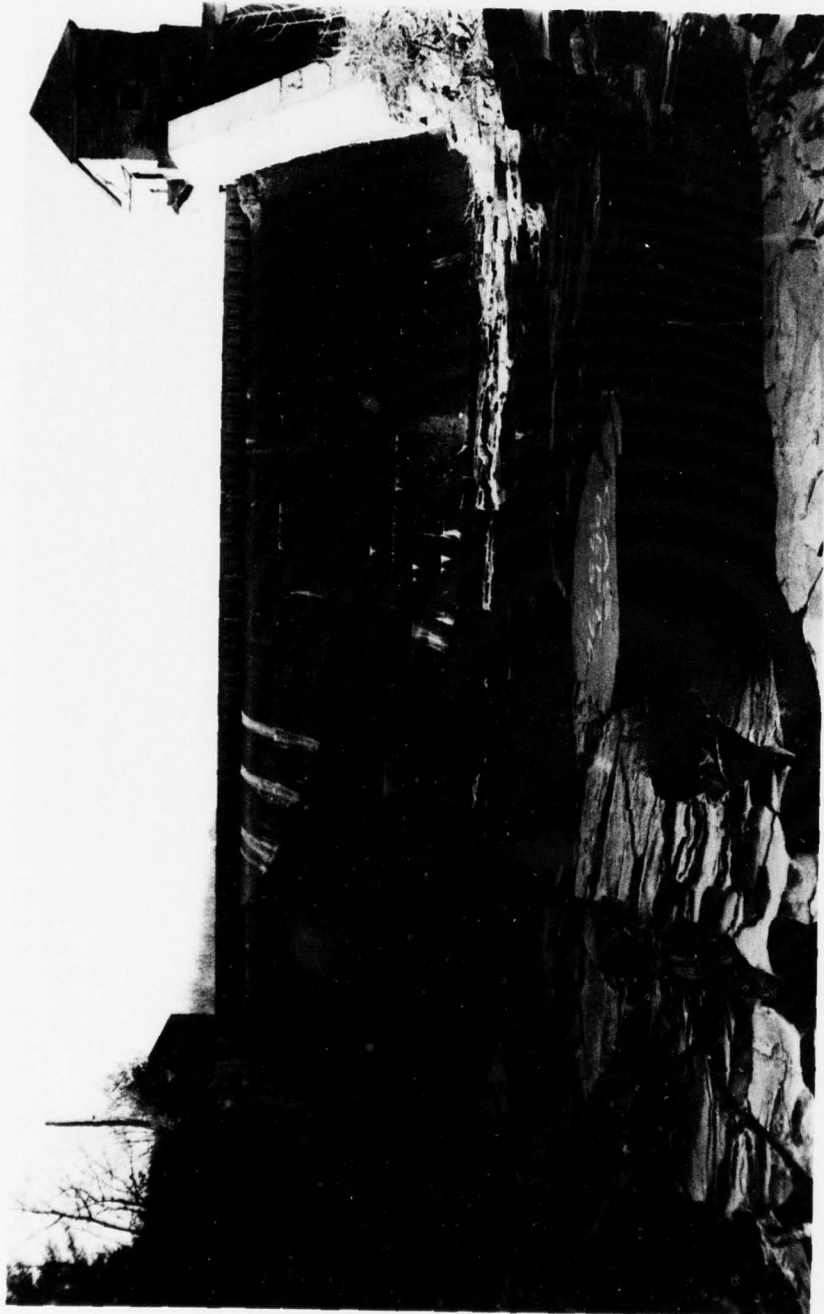
Overview of Spillway
Photo #2

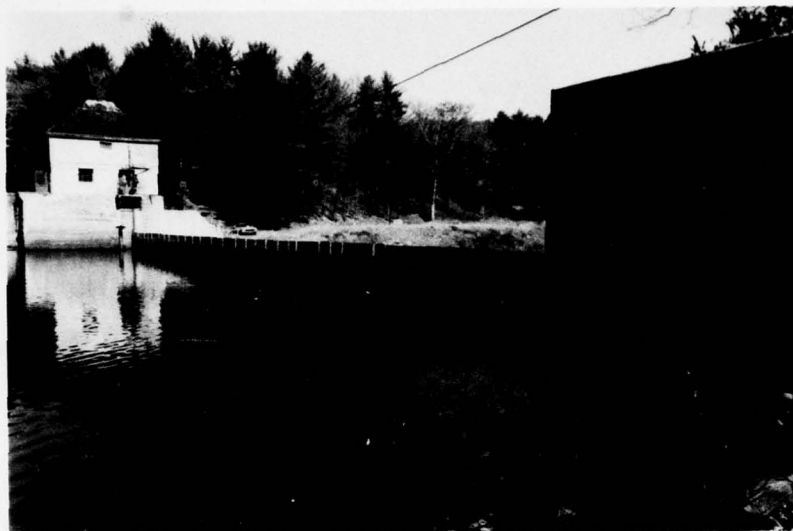
Spillway Viewed from Upstream
Note Flashboards
Photo #3

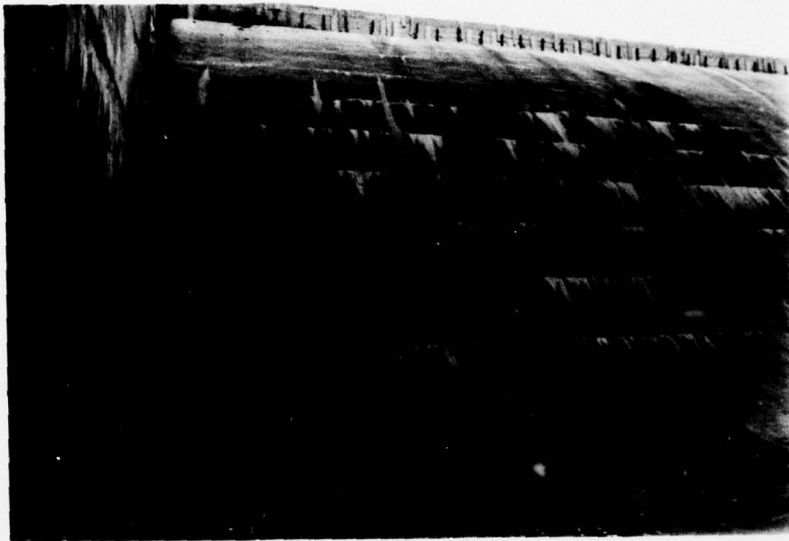
Seepage was also observed at the south spillway buttress and at the rock outcrop behind the buttress. (See photos #5 & 10) Flow is estimated to be in excess of 15 gpm.

South Abutment Wall and Spillway Viewed from Downstream
Note Deterioration and Calcification
Photo #5

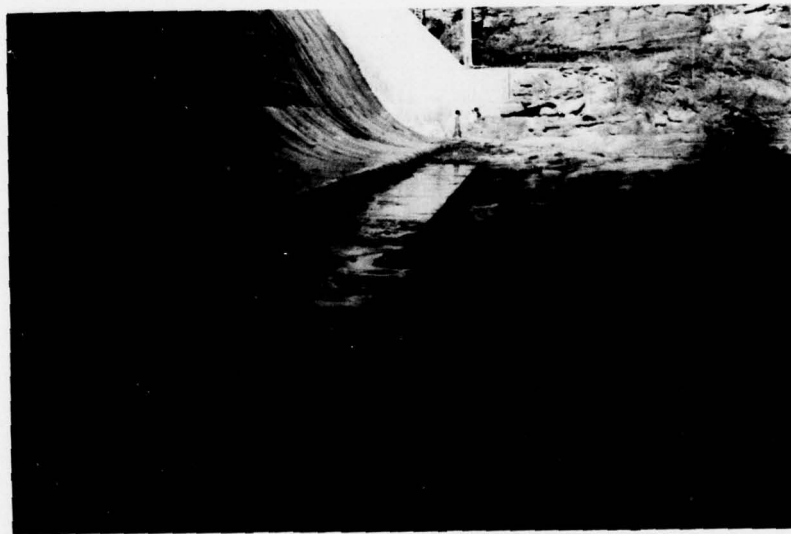
Spillway Viewed from Downstream
Note Poured Concrete at the Toe of Spillway
and
Water Pool on the Right Corner
Photo #6

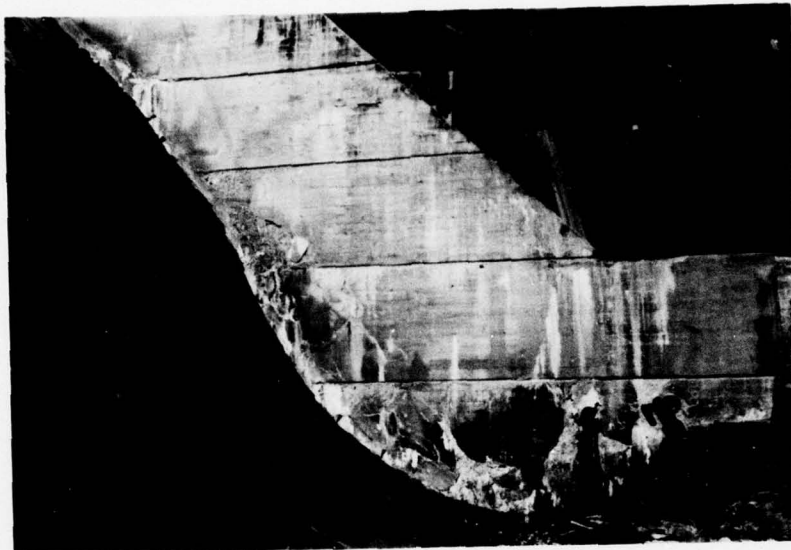
Seepage was observed flowing from a 6-inch drain pipe protruding from the north spillway buttress. This flow was estimated to be 25 gpm. (See photos #7 & 8) This flow is believed to be caused by seepage from the rock outcrop and gate house at the north abutment of the spillway. (See photo #16) The remaining pipes were not flowing.

Concrete surfaces are deteriorated particularly at the north buttress, the gate house, the intake wingwalls, and the non-overflow section. (See photos #7, 11, 12, & 16) While deterioration was extensive, no evidence of settlement, movement, or misalignment was noted. Seepage was observed above the penstock emanating from the east wall of the gate house. This seepage is an indication of the concrete deterioration of the gate house wall. (See photo #16) Extensive vegetation was evident south of the south spillway buttress.

North Abutment Wall and Spillway
Note Seepage and Deterioration
Photo #7

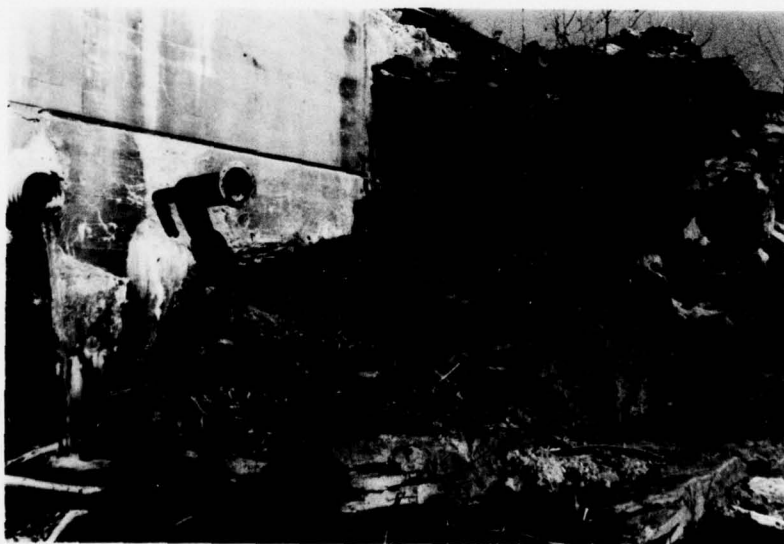
The spillway is founded on and keyed into bedrock. The outlet and downstream channel are also bedrock controlled. The bedrock at the toe of the spillway was rock-bolted to insure the stability of the spillway. A rock bolt is evident in photo #8, right foreground.

Closeup View of Seepage on Photo #7
Photo #8

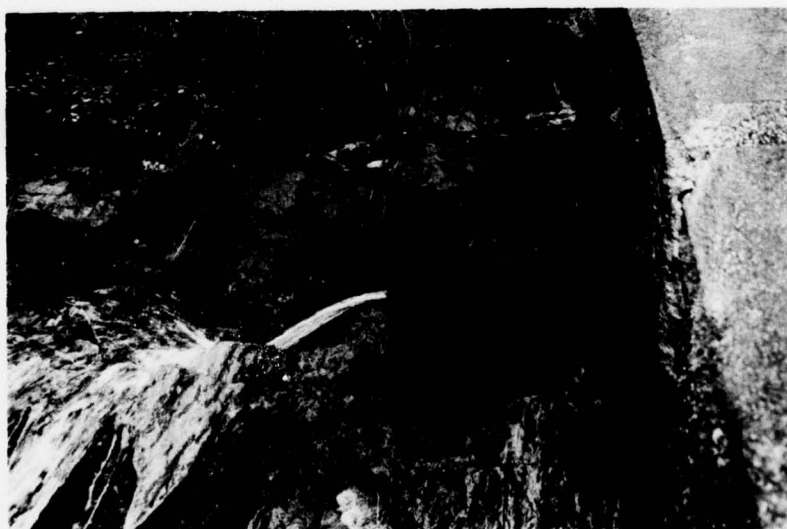
Seepage Near South Abutment
Photo #10

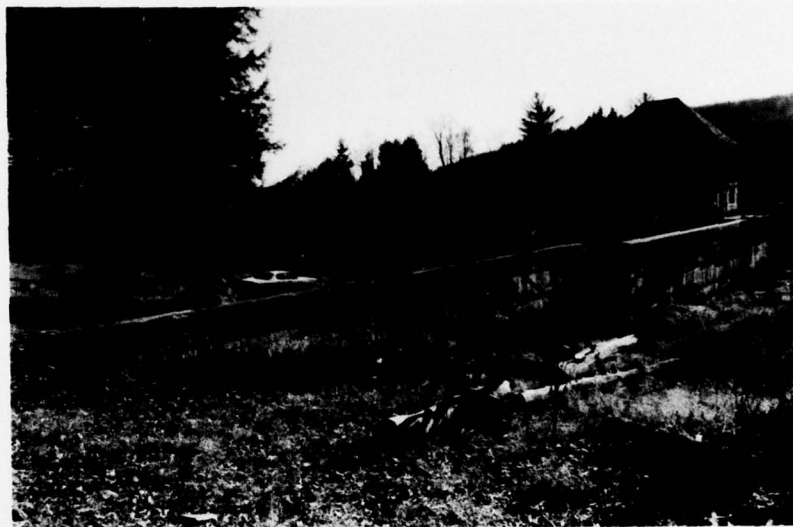
Concrete Retaining Wall and Gate House Viewed from Upstream
Note Concrete Deterioration
Photo #11

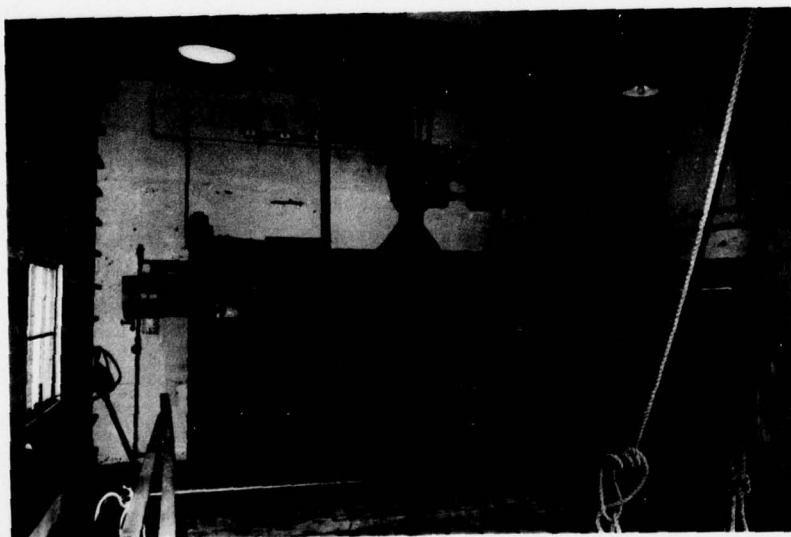
An 8-foot diameter wood stave penstock provides the only outlet from the reservoir. This penstock and the vertical slide gate located in the gate tower appeared to be in good condition. (See photos #1,13,14,15, & 18) The penstock terminates at the generating station approximately 2800 feet east of the dam.

Vertical Slide Gate at Intake
Photo #14

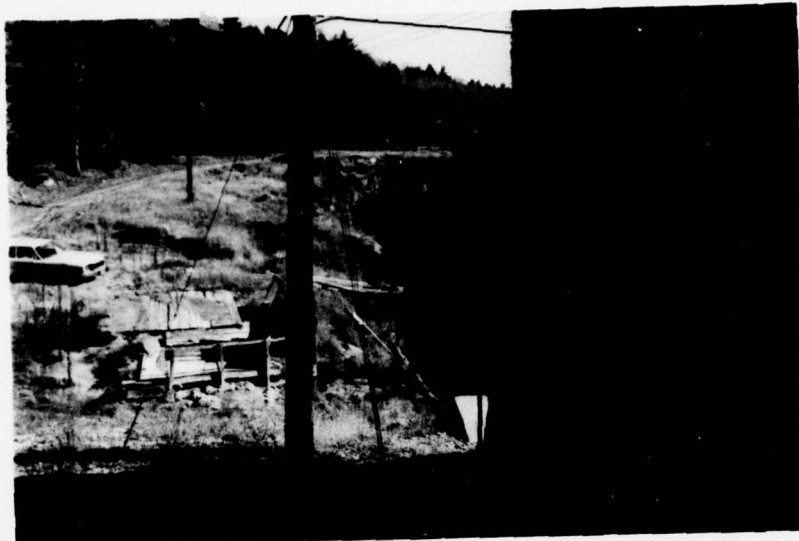
Gate House, Wood Stave Pipe (Penstock), and Access Road
Photo #15

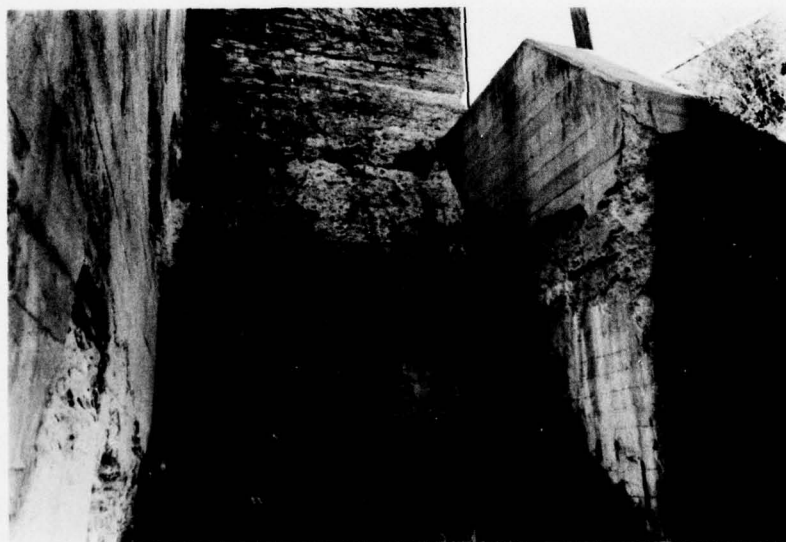
North Abutment (left), Gate House (center), and Retaining Wall (right)
Viewed from Downstream
Note Concrete Deterioration
Photo #16

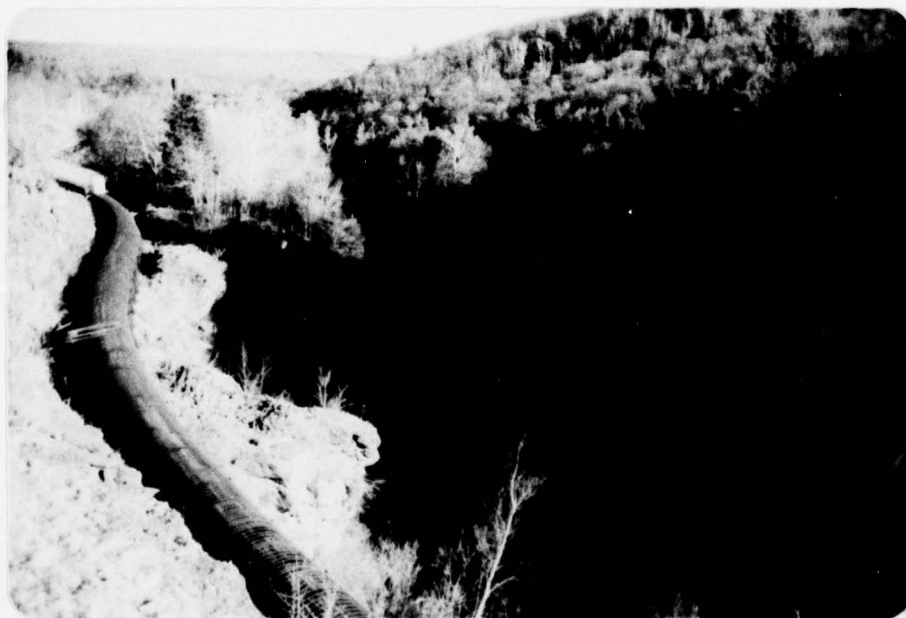
Tailrace Channel and Penstock
Photo #18

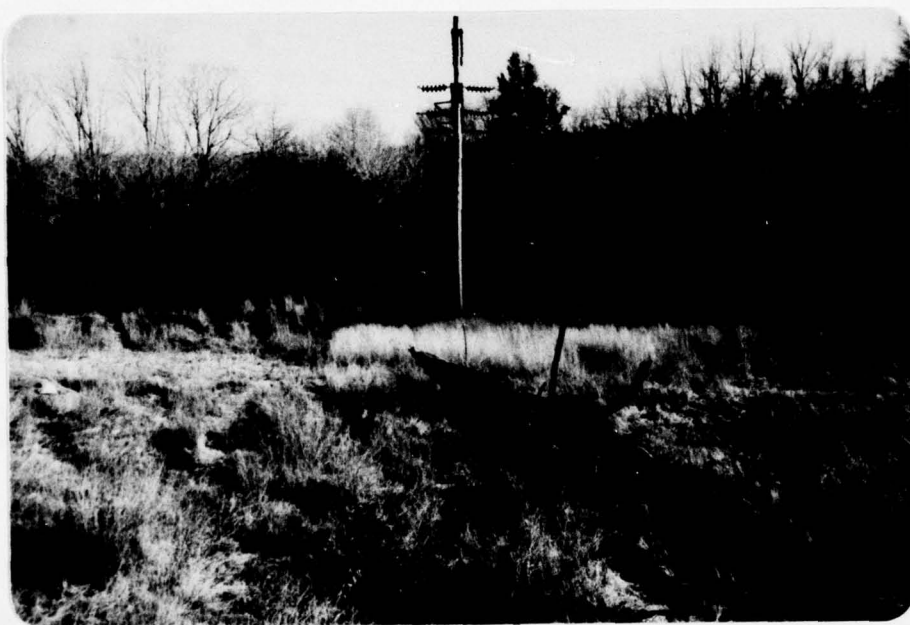
The earth embankment south of the spillway was in good condition. No evidence of seepage or misalignment was observed. Three depressions were noted on the upstream side of the embankment. (See photos #19, 20, & 21) The cause of these depressions is unknown. The distance from the earth embankment and the height above normal reservoir levels warrent only filling of these depressions. The earth embankment was heavily vegetated.

Earth Embankment (Closure Dike) in the Background
Southwest of Spillway
Photo #19
